Mars Exploration Rovers

2017 2018

One Martian Year • Two Earth Years

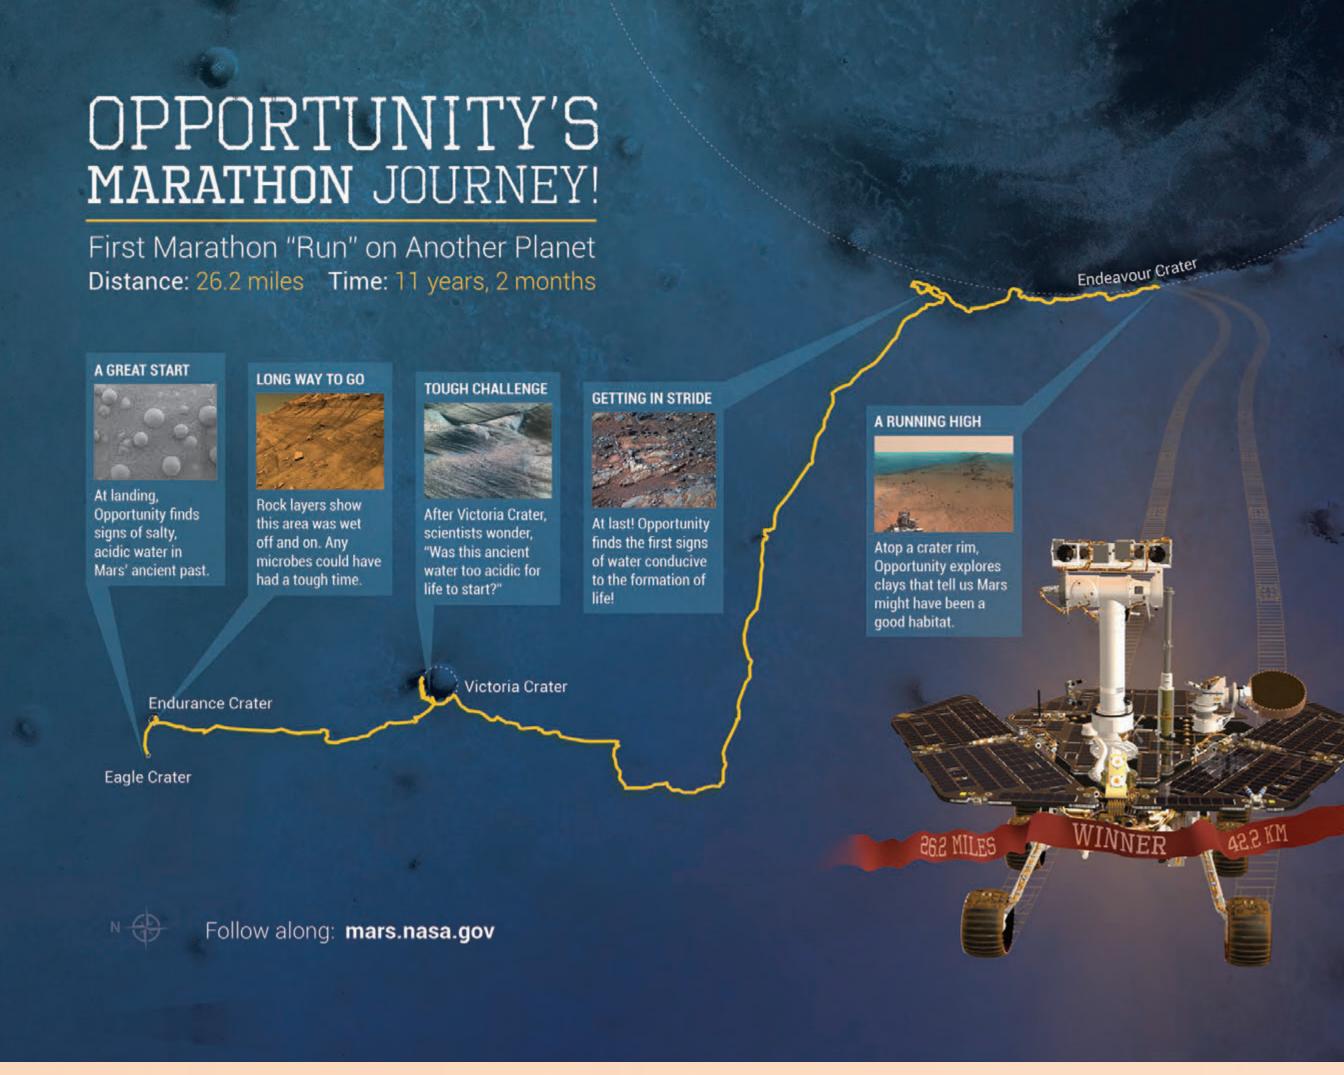
Opportunity's Marathon Journey

Eleven years and two months after landing on Mars, the total driving distance of NASA's Mars Exploration Rover Opportunity surpassed the length of a marathon race: 26.219 miles (42.195 kilometers). This map shows the southward path driven by Opportunity from late January 2004 until it passed marathon distance on March 24, 2015, during the 3,968th sol of the rover's work on Mars.

The rover's traverse shown here has been mapped onto an image from the High Resolution Imaging Science Experiment (HiRISE) camera on NASA's Mars Reconnaissance Orbiter. Image credit: NASA/JPL-Caltech/Univ. of Arizona

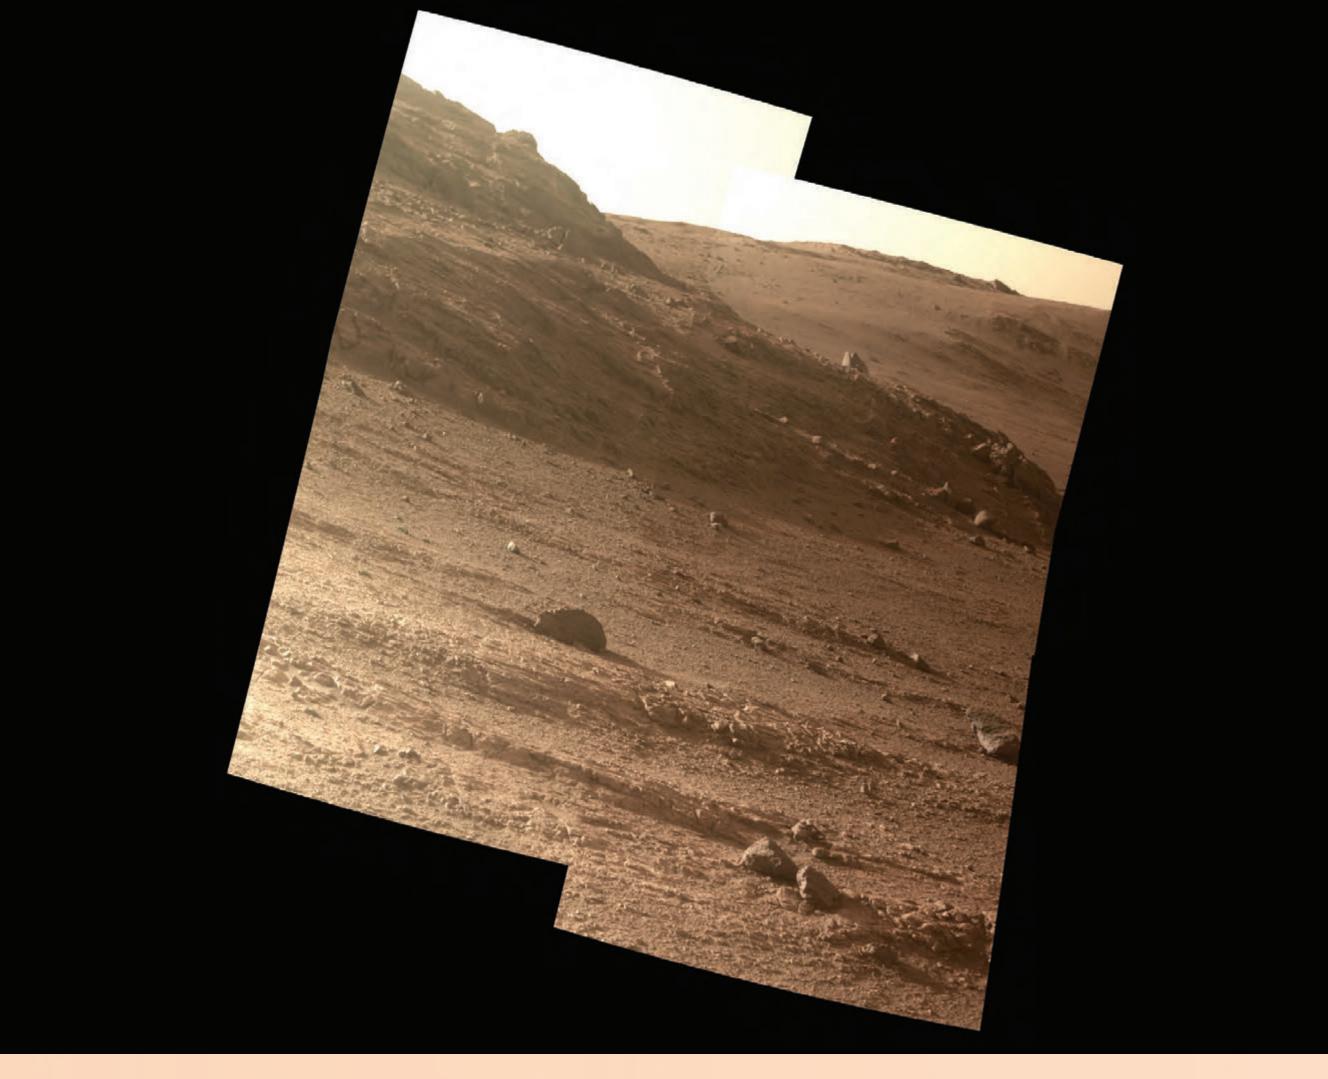
Marathon Valley North Wall

This field of view features part of the north wall of Marathon Valley, to the northwest of the Opportunity rover.

This mosaic—with a field of view of approximately 30 degrees—was acquired with Opportunity's panoramic camera (Pancam) on Sol 4,087 (July 24, 2015). Pancam's 753nm, 535nm, and 432nm filters were used in making this mosaic. Image credit: NASA/JPL-Caltech/Cornell Univ./Arizona State Univ.

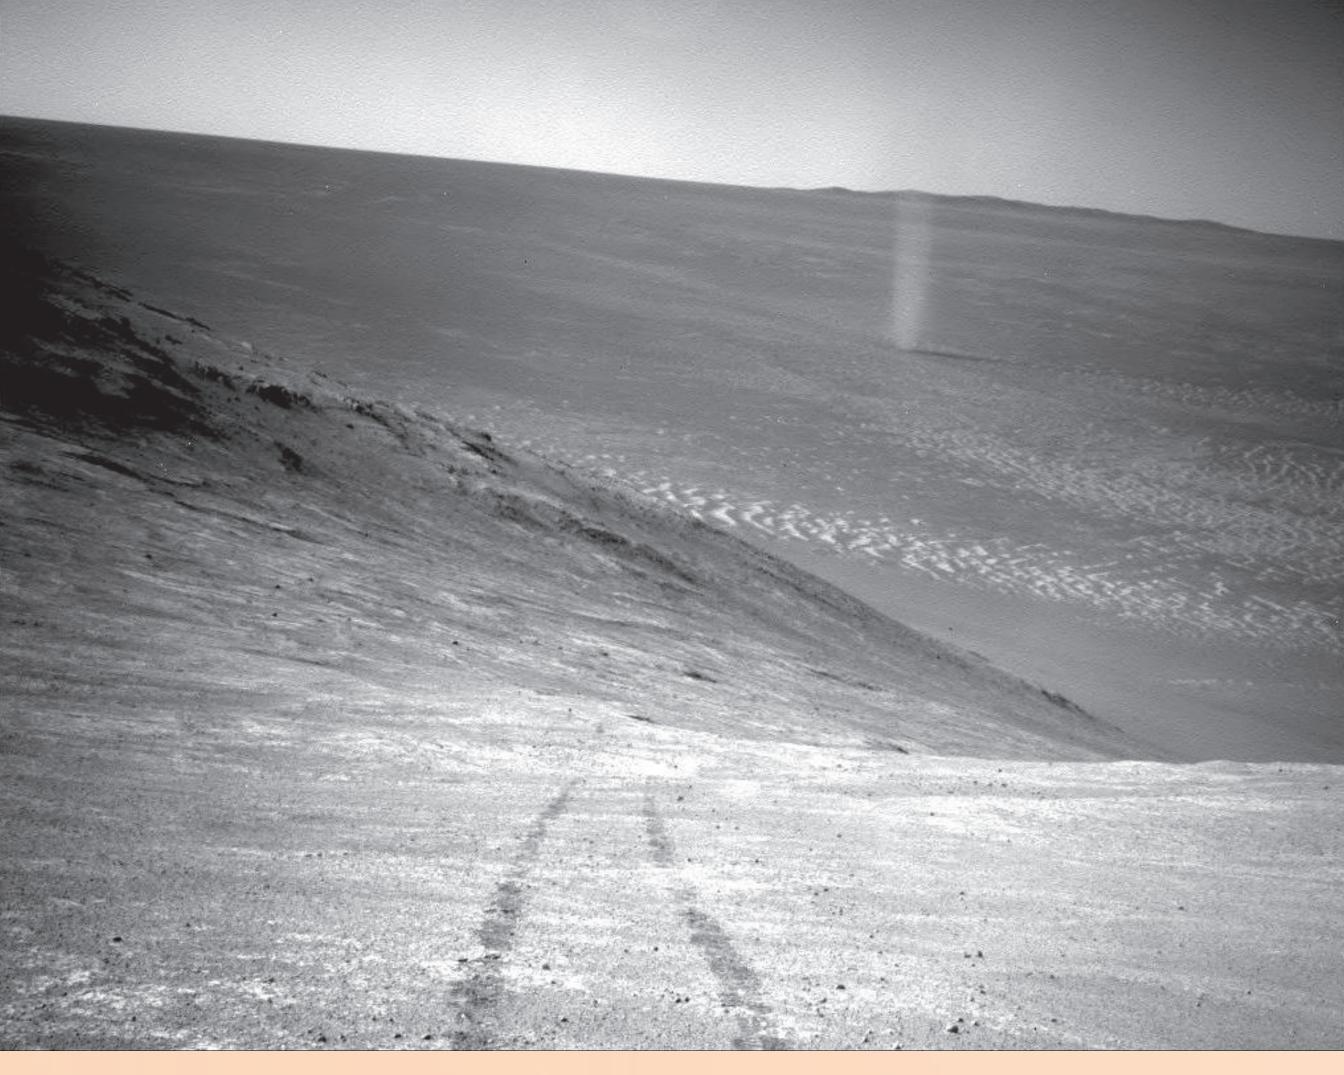
Martian Dust Devil

From its perch high on the rim of Endeavour crater, Opportunity recorded this image of a Martian dust devil twisting through the crater floor below. The view looks back at the rover's tracks leading up the north-facing slope of Knudsen Ridge, which forms part of the southern edge of Marathon Valley. Just as on Earth, a dust devil is created by a rising, rotating column of hot air. When the column whirls fast enough, it picks up tiny grains of dust from the ground, making the vortex visible. Dust devils were a common sight for Opportunity's twin rover, Spirit, in its outpost at Gusev crater. However, dust devil sightings—like this one—have been rare for Opportunity.

Opportunity captured this image using its navigation camera on Sol 4,332 (March 31, 2016). Image Credit: NASA/JPL-Caltech

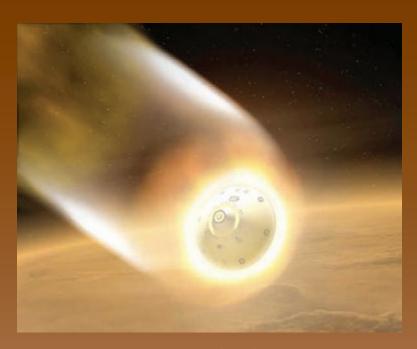
The aeroshell protects the rover from fiery temperatures as it enters the Martian atmosphere. (Artist's rendering)
